Galleon Cottage,
Peinmore,
Skeabost Bridge,
Portree,
Isle Of Skye,
IV51 9PG

Home Report

Single Survey

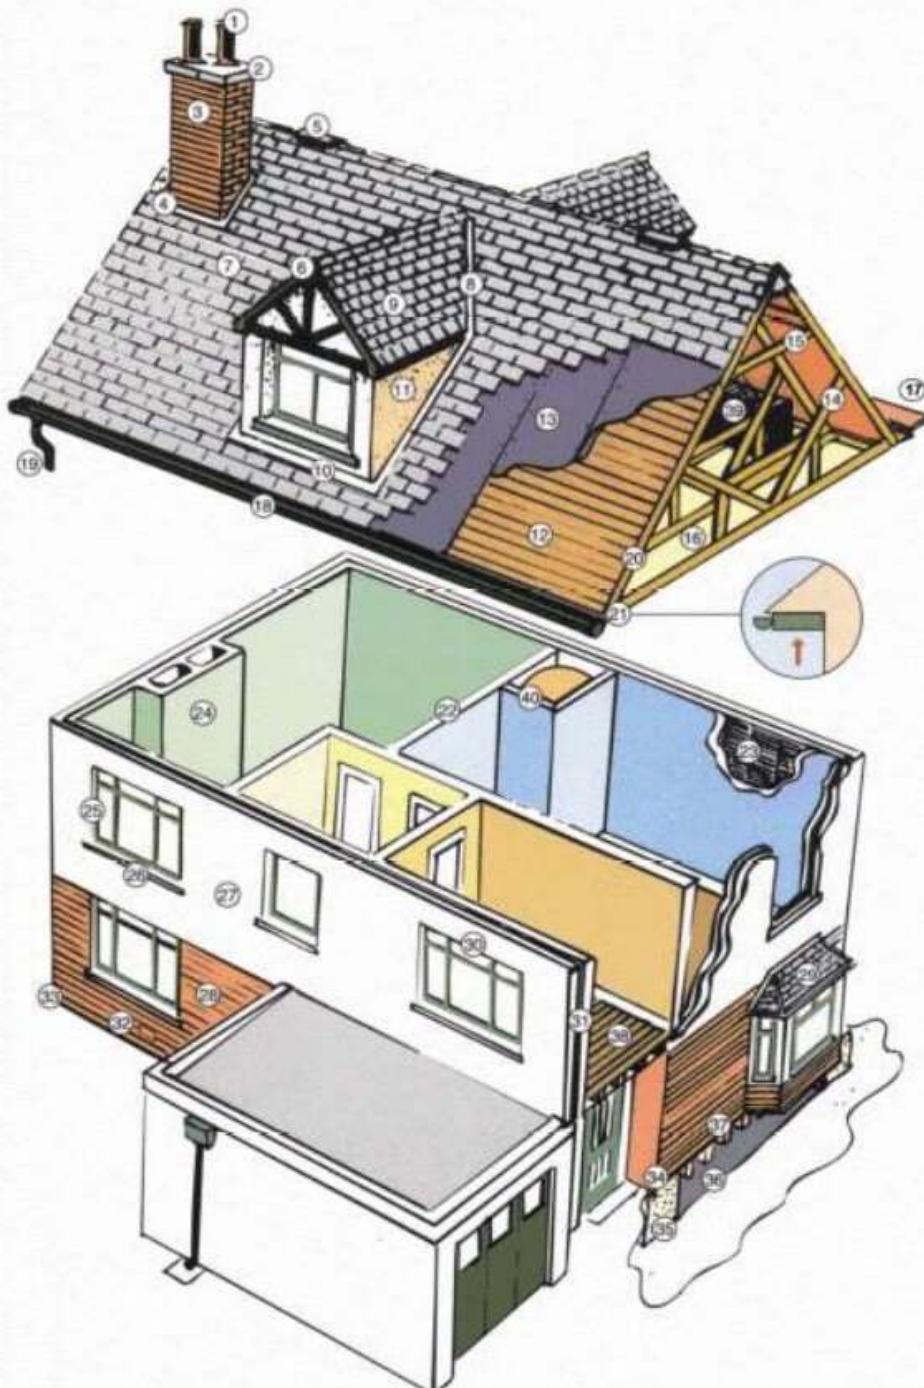
Sectional Diagram showing elements of a typical house

- 1 Chimney pots
- 2 Coping stone
- 3 Chimney head
- 4 Flashing
- 5 Ridge ventilation
- 6 Ridge board
- 7 Slates / tiles
- 8 Valley guttering
- 9 Dormer projection
- 10 Dormer flashing
- 11 Dormer cheeks
- 12 Sarking
- 13 Roof felt
- 14 Trusses
- 15 Collar
- 16 Insulation
- 17 Parapet gutter
- 18 Eaves guttering
- 19 Rainwater downpipe
- 20 Verge boards / skewers
- 21 Soffit boards
- 22 Partition wall
- 23 Lath / plaster
- 24 Chimney breast
- 25 Window pointing
- 26 Window sills
- 27 Rendering
- 28 Brickwork / pointing
- 29 Bay window projection
- 30 Lintels
- 31 Cavity walls / wall ties
- 32 Subfloor ventilator
- 33 Damp proof course
- 34 Base course
- 35 Foundations
- 36 Solum
- 37 Floor joists
- 38 Floorboards
- 39 Water tank
- 40 Hot water tank

Reference may be made in this report to some or all of the above component parts of the property. This diagram may assist you in locating and understanding these items.
